1. Purpose and scope of this memorandum

This memorandum summarizes a site survey performed July 5, 2018 to evaluate the condition of ADA mandated access at the Town Landing in Pembroke Massachusetts. After a description of the site and site uses, recommended improvements are provided in Section 7, beginning on page 3.

Town Landing is a small developed public area on the east shore of Oldham Pond, accessed from a paved parking area or diagonal off street parking on the west side of Wampatuck Street.

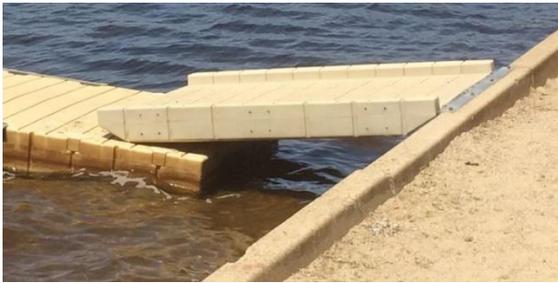
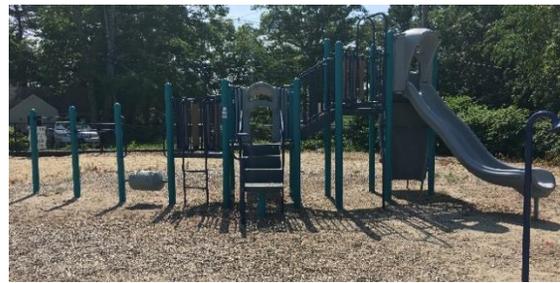
Town Landing contains paved parking, a small boat launch ramp and adjacent float dock, roughly 21,300 square feet of sandy area with two float docks for swimming, a children's' play area, 4 picnic tables and a restroom building. Access from the parking area to the sandy area is through a gate. Access to the play area and swimming floats is across approximately 100 feet of loose sand.

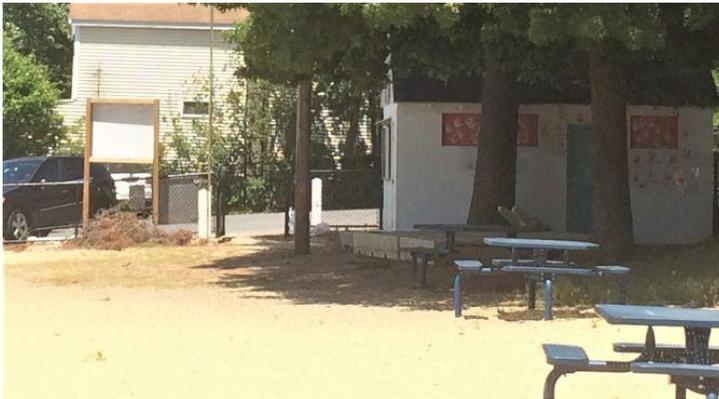
There are no outdoor recreation access routes (ORAR) within the entire site. In order for there to be access to the picnic tables, play area of swimming floats, they need to be along a ORAR. The boat ramp and adjacent float are along the paved surface of the parking area.

- i. Lack of accessible surfacing. In order for a pathway to be considered an ORAR, the surfacing has to be accessible. Acceptable surfacing material include a beach mat, concrete, asphalt, crushed stone, packed soil and soil stabilizer. The only available surfacing is sand, which is not considered an accessible surface.
- ii. Inaccessible float docks. the float docks designated for swimming are currently inaccessible due to the top of the concrete wall being raised above the surface of the sand.

- a. A short-term improvement would include placement of a removable beach mat from the gate to the play area and placement of another mat perpendicular to the first mat that leads down to one of the float docks. Sand beneath the mat would need to be smoothed and should have a running slope no greater than 10% and a cross slope no greater than 5%. The running slope and cross slope is recommended, but not required for removable mats.
- b. If the mat ran to the edge of the float, the transition between the mat and the float would need to be modified to assure that all height differences were 1 inch or less and that the float was modified to be ADA compliant. This includes adding detectable warning strips along the edges of the float dock, adding a transition plate from the sand to the top of wall/beginning of the ramp to the dock, adding a transition plate from the

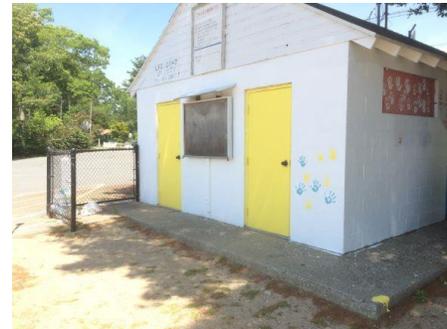
There is a single restroom in the concrete storage building. Access to the restroom is from the sandy area and involves a 4-inch step to a 14-inch wide apron along the side of the building.
